Stream Segment 27 in UPZ N-4

Plan View of Stream Segment 29
Interim Stormwater Hydrology and Hydraulics Report for Lower Little Salt Creek Watershed

Interim Stormwater Hydrology and Hydraulics Report for Lower Little Salt Creek Watershed

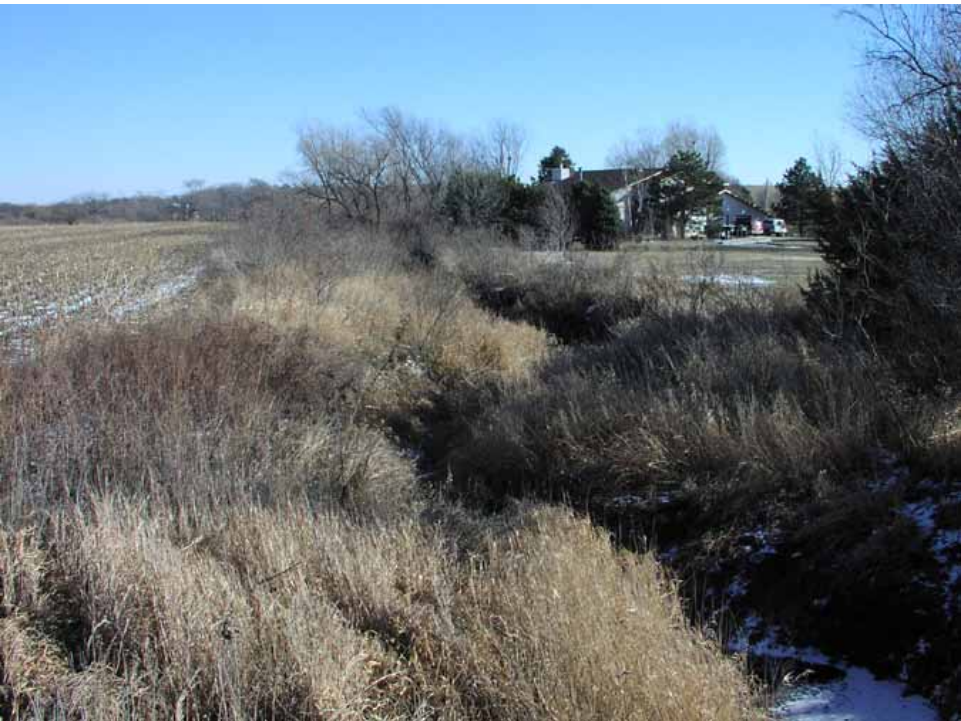
Photo 43: Looking downstream from North 27th Street..

This reach shows a few signs of active stream bed and bank erosion. The channel has been straightened east of North 14th Street along Arbor Road. The channel has approximately a 2-year capacity. Velocities through the North 14th Street bridge and for ⅛ -mile downstream are erosive for floods with an average return frequency of 10-years or longer.
- Flood Hazard

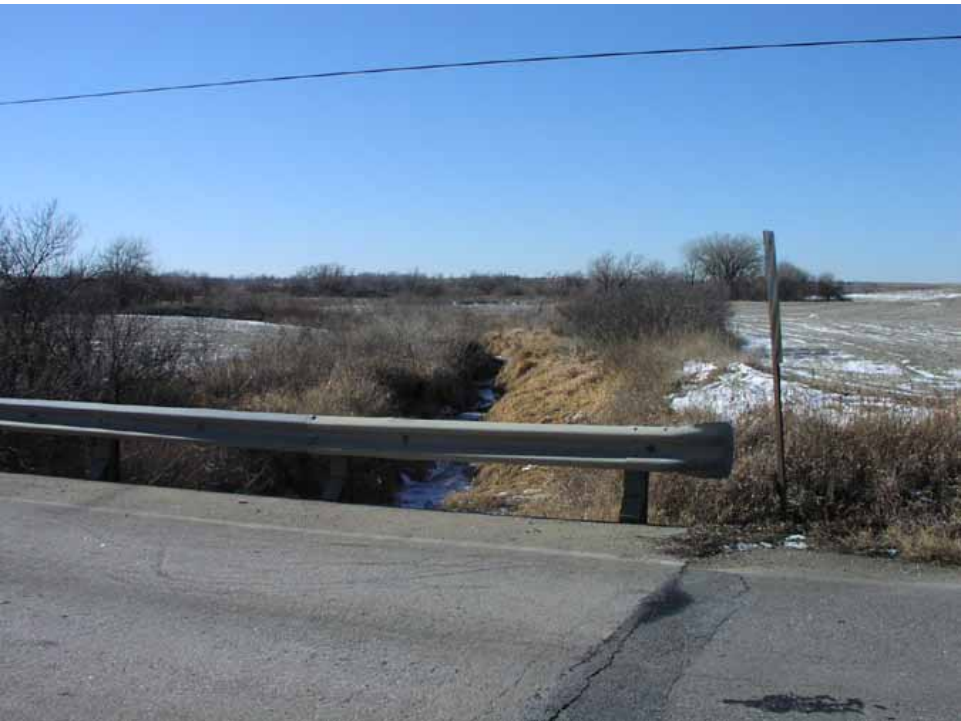
Photo 44: Looking upstream from North 14th Street.

There is no immediate threat apparent to overhead or buried utilities in the road ROW. The roadway crossing at North 14th Street meets minimum DCM requirements (see the hydraulics section for more information on overtopping frequency). Additional flow comes from a tributary located north of the bridge. Flows escape from the tributary for flow rates greater than the rate for the 2-year storm and follow the road ditch south to the N-4 mainstem, increasing the flow through the bridge.
- Water Quality

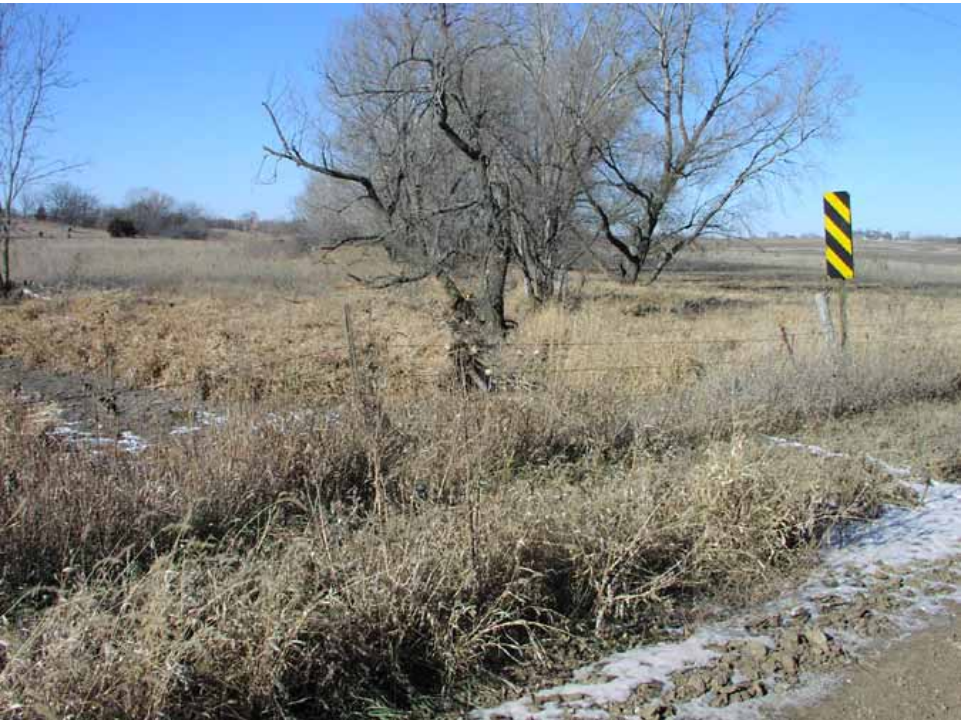
Photo 45: Looking upstream from North 7th Street.

This reach shows signs of active stream bed and bank erosion. The predominant factor is head cutting that is proceeding upstream from the straightened reach of channel. The culvert at North 7th Street provides hard point in the channel. The channel has approximately a 2-year capacity and non-erosive velocities.
- Flood Hazard

There is no immediate threat apparent to overhead or buried utilities in the road ROW. The roadway crossing at North 7th Street does not meet DCM minimum requirements (see the hydraulics section for more information on overtopping frequency).
- Water Quality

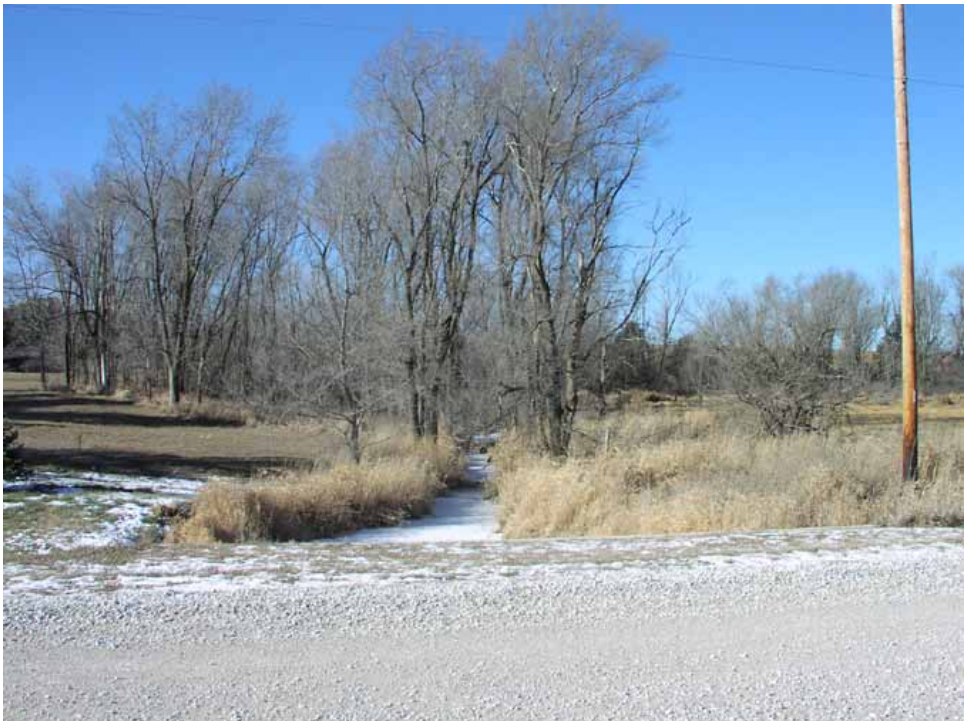
Photo 46: Looking upstream from North 1st Street.

This reach shows few signs of active stream bed and bank erosion. The culverts at North 7th Street and at McKelvie Road serve as hard points in the channel. The channel has approximately a 2-year capacity and non-erosive velocities. Erosive velocities would occur between North 1st Street and McKelvie Road during the 100- and 500-year floods.
- Flood Hazard

There is no immediate threat apparent to overhead or buried utilities in the road ROW. The roadway crossing at North 1st Street meets DCM minimum requirements for overtopping but the crossing at McKelvie Road does not (see the hydraulics section for more information on overtopping frequency).
- Water Quality

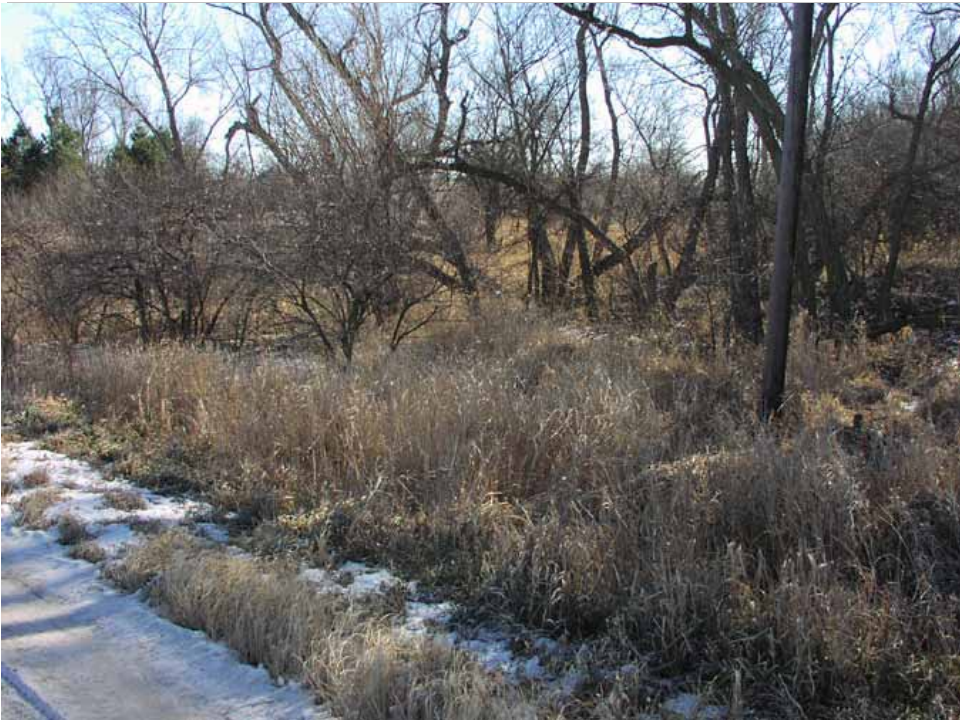
Photo 48: Looking downstream from Waverly Road.

- Reach Stability This reach shows no signs of active stream bed and bank erosion. The culvert at Bluff Road serves as a hard point in the channel. The channel has approximately a 1-year capacity and non-erosive velocities.

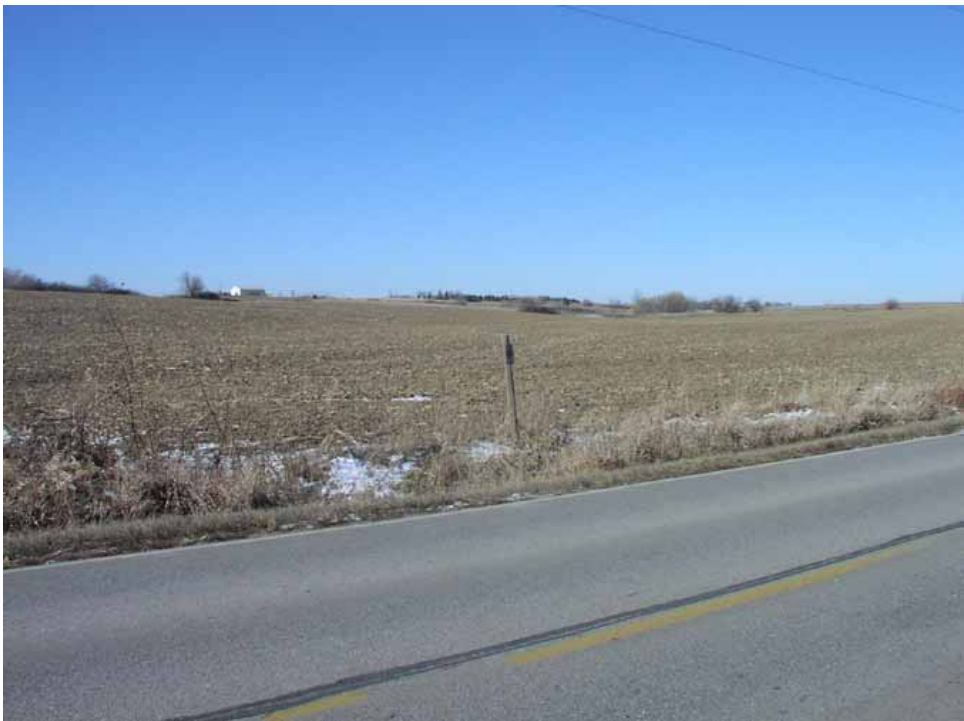
Photo 50: Looking upstream from North 14th Street.

This reach shows no signs of active stream bed and bank erosion, there is no well defined channel. The culvert at North 14th Street serves as a hard point in the channel. The channel has approximately a 2-year capacity and non-erosive velocities upstream of North 14th Street. Erosive velocities would occur below North 14th Street.
- Flood Hazard

There is no immediate threat apparent to overhead or buried utilities in the road ROW. The roadway crossing at North 14th Street does not meet DCM minimum requirements for overtopping (see the hydraulics section for more information on overtopping frequency). Flow in excess of culvert capacity follows the road ditch south to the mainstem channel.
- Water Quality

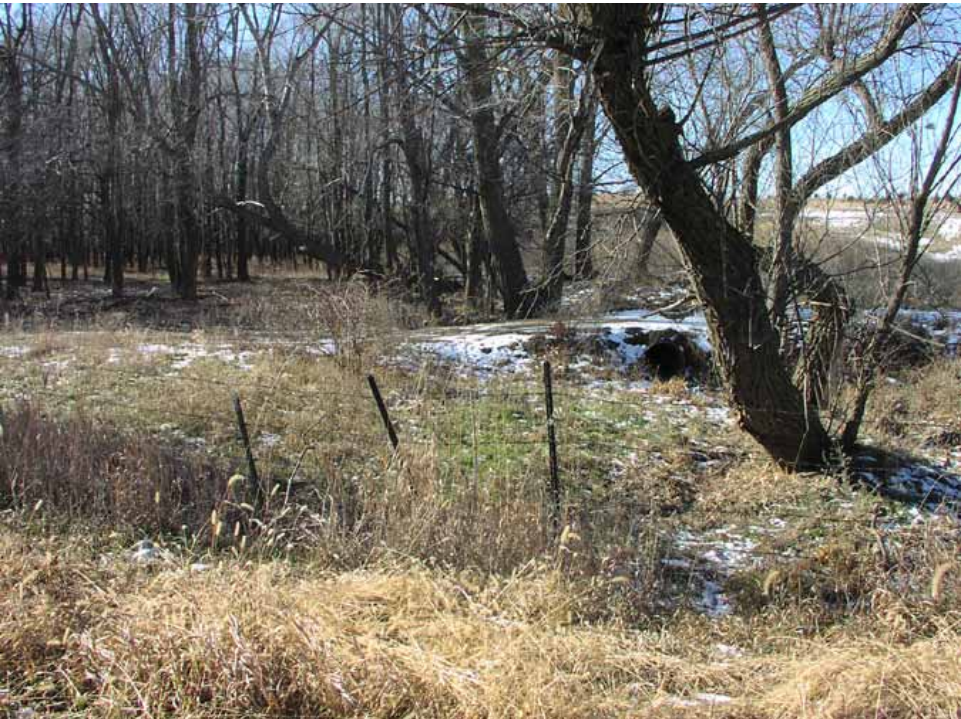
Photo 52: Looking upstream from North 7th Street.

This reach shows no signs of active stream bed and bank erosion. The culvert at North 7th Street serves as a hard point in the channel. The channel has approximately a 1-year capacity and non-erosive velocities.
- Flood Hazard

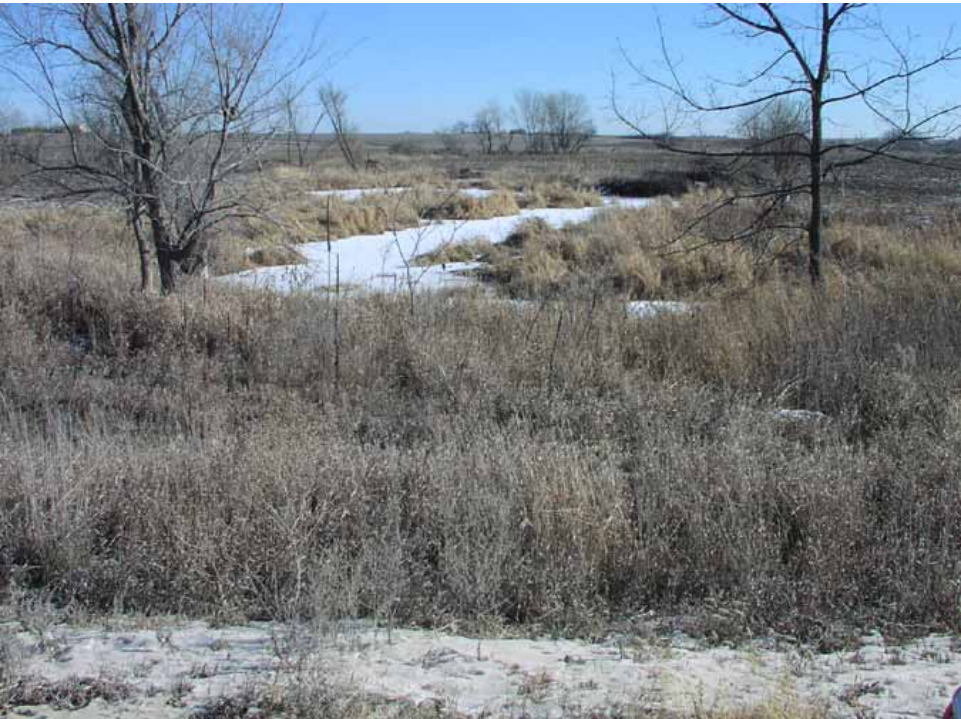
Photo 53: Looking downstream from North 1st Street.

This reach shows no signs of active stream bed and bank erosion. The culvert at North 1st Street serves as a hard point in the channel. The channel has approximately a 1-year capacity and non-erosive velocities.
- Flood Hazard

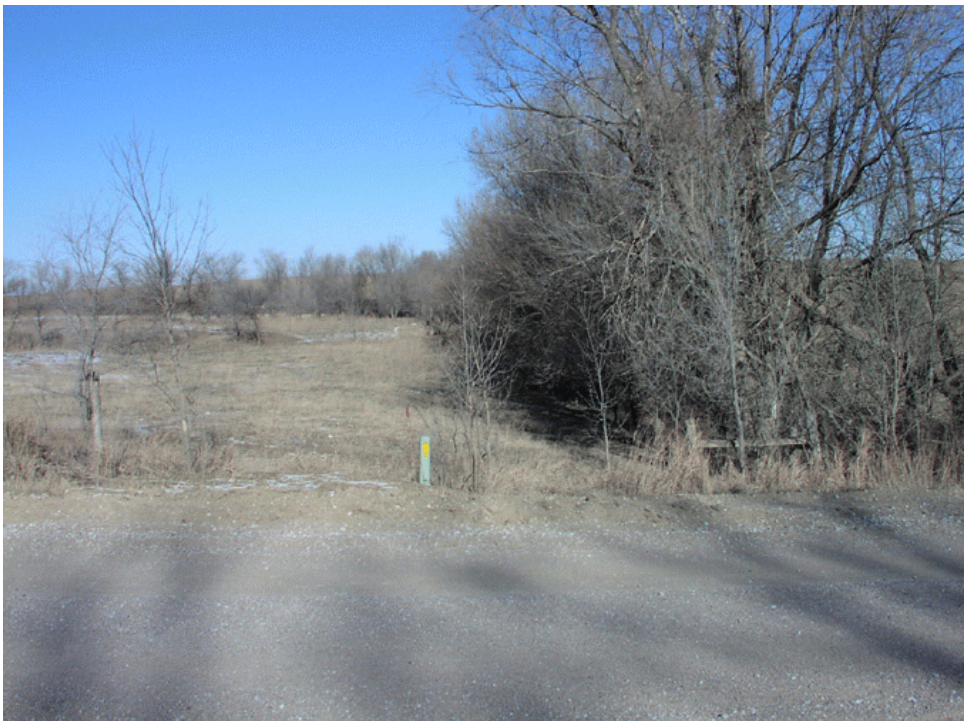
Photo 54: Looking downstream from 14th Street.

This reach shows signs of active stream bed and bank erosion near the confluence with Little Salt Creek. The predominant factor causing this erosion is head cutting that is proceeding upstream from Little Salt Creek. The culvert at North 14th Street serves as a hard point in the channel. Erosive velocities occur during the 500-year storm. The channel has an approximate 1-year capacity and non-erosive velocities, except erosive velocities would occur during the 500-year storm downstream of North 14th Street.
- Flood Hazard

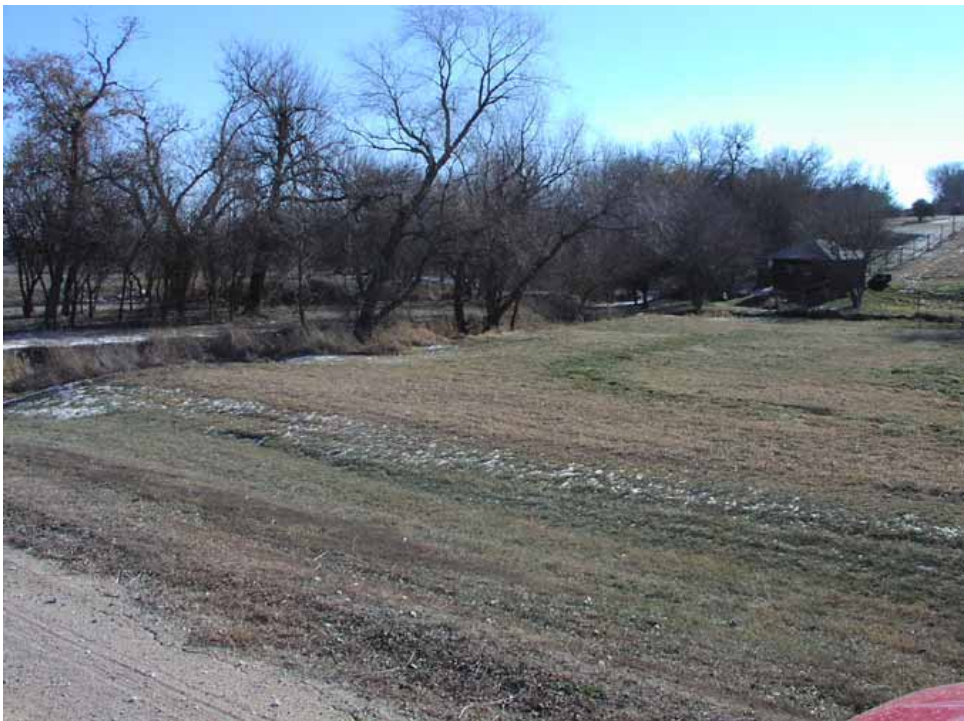
Photo 56: Looking downstream from Waverly Road.

This reach shows signs of active stream bed and bank erosion. There is some scour at the outlet of the North 1st Street culvert. The channel has an approximate 2-year capacity and non-erosive velocities, except erosive velocities would occur during the 500-year flood downstream of Waverly Road. The culverts at Waverly Road and at North 1st Street serve as hard points in the channel.
- Flood Hazard

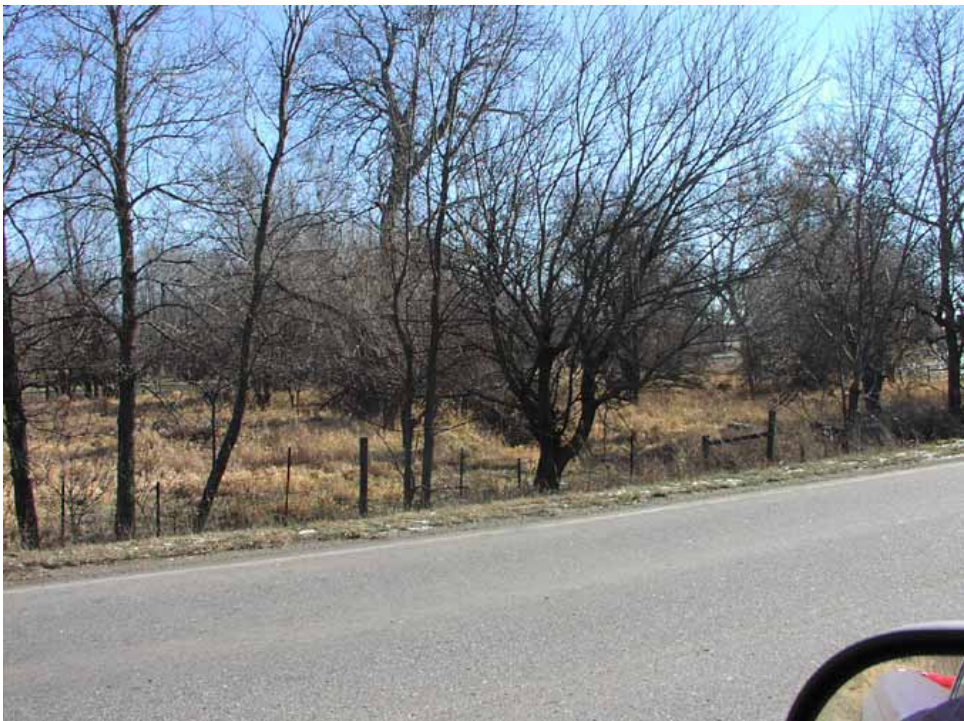
Photo 60: Looking downstream from North 14th Street.

This reach shows signs of active stream bed and bank erosion near the confluence with Little Salt Creek. The predominant factor causing this erosion is head cutting proceeding upstream from Little Salt Creek. The grade stabilization structure serves as a hard point in the channel. The channel has an approximate 2-year capacity and non-erosive velocities.
- Flood Hazard

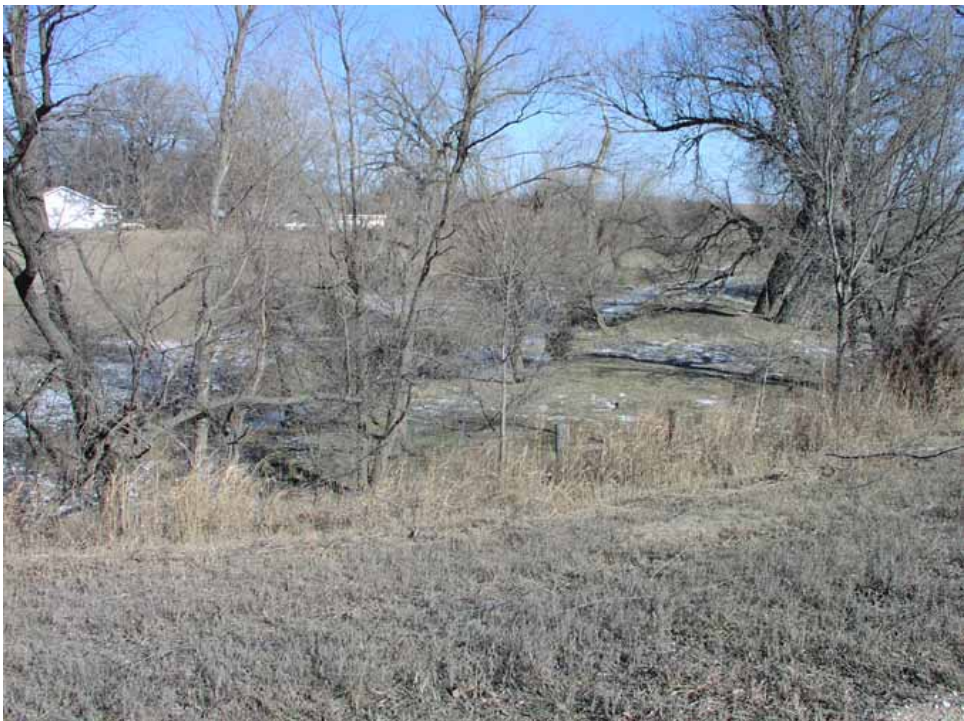
Photo 62: Looking downstream from Waverly Road.

This reach shows no signs of active stream bed and bank erosion. The culverts at Waverly Road and North 27th Street serve as hard points in the channel. The channel has approximately a 100-year capacity and non-erosive velocities.
- Flood Hazard

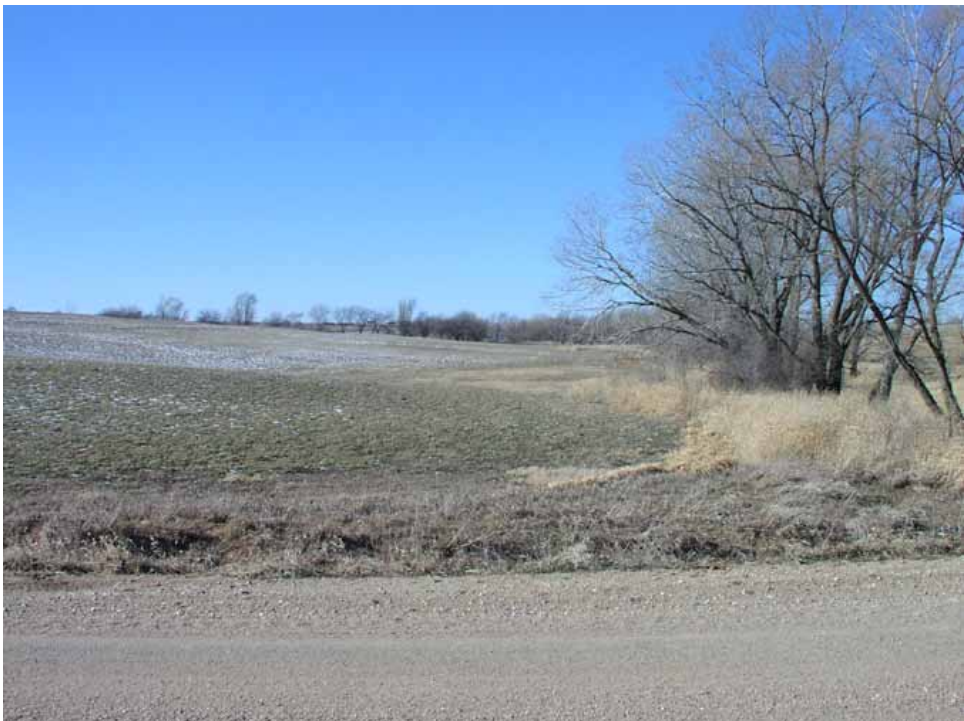
Photo 64: Looking upstream from North 1st Street.

This reach shows no signs of active stream bed and bank erosion. The culvert at North 1st Street serves as a hard point in the channel. The channel has an approximate 2-year capacity and non-erosive velocities.
- Flood Hazard
